Non-Destructive Measurement Methods (Neutron-, X-ray Radiography, Vibration Diagnostics and Ultrasound) in the Inspection of Helicopter Rotor Blades

M. Balaskó¹, G. Endrőczy², Gy. Tarnai³, I. Veres⁴, Gy. Molnár⁴, E. Sváb⁵

¹KFKI Atomic Energy Res. Inst. H-1525 Budapest, POB. 49.

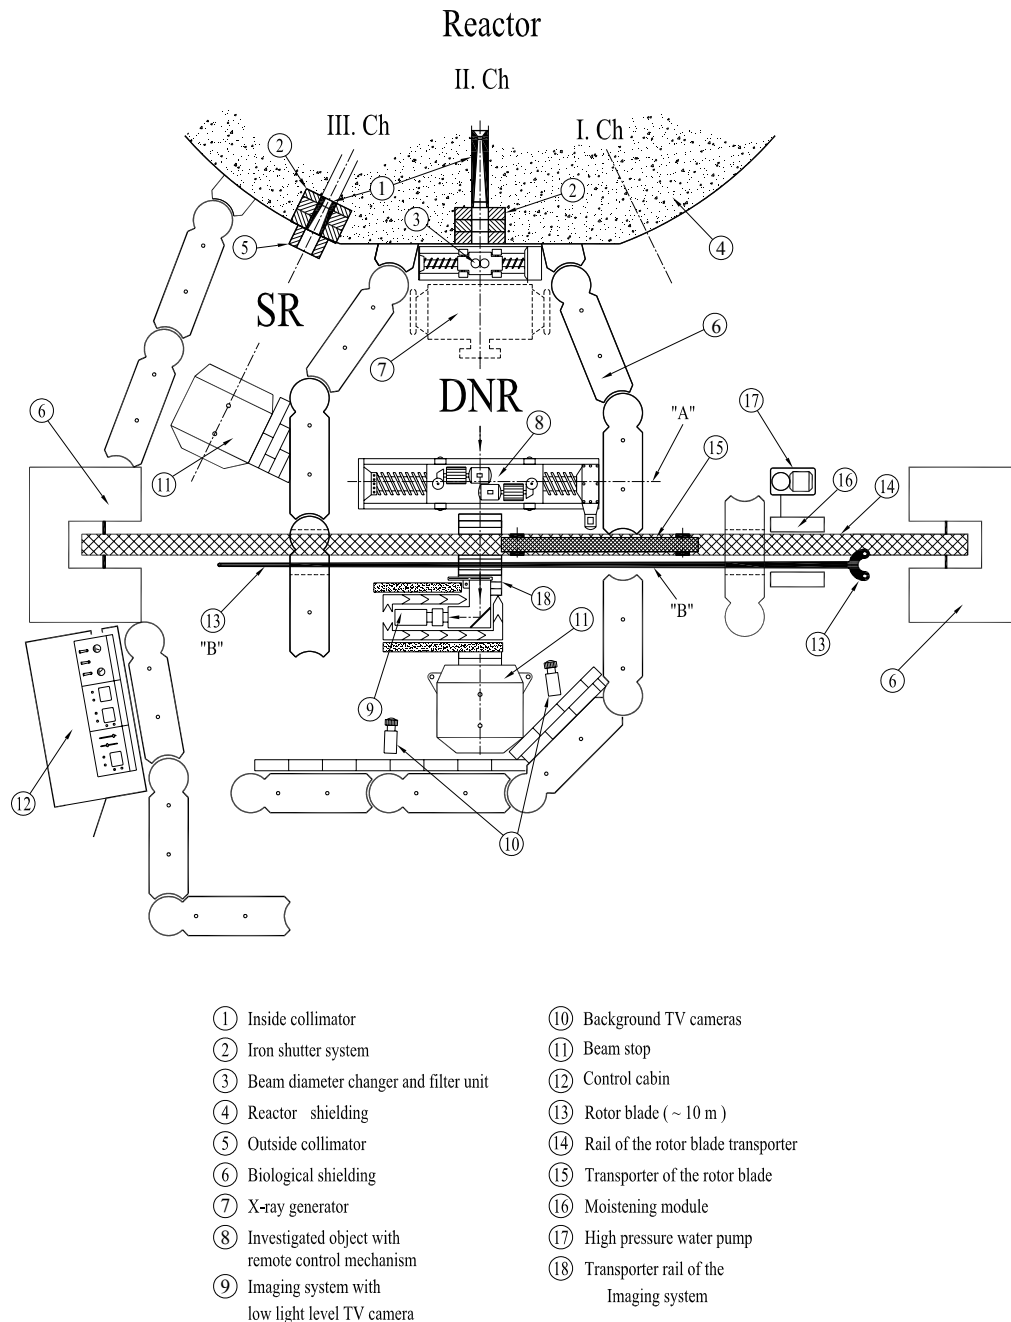
The experiments were performed at the Dynamic Radiography Station (DRS) of the Budapest reactor [2] where the necessary developmental work, with respect to the sizes of the rotor blades, was carried out. As a result, the reconstructed DRS can inspect 10 m long and 0.7 m wide targets (its weight is ~140 kg) by NR, XR and VD. The arrangement of the experimental set up is shown in Fig. 1.

Figure 1: Arrangement of the experimental set up of DRS.

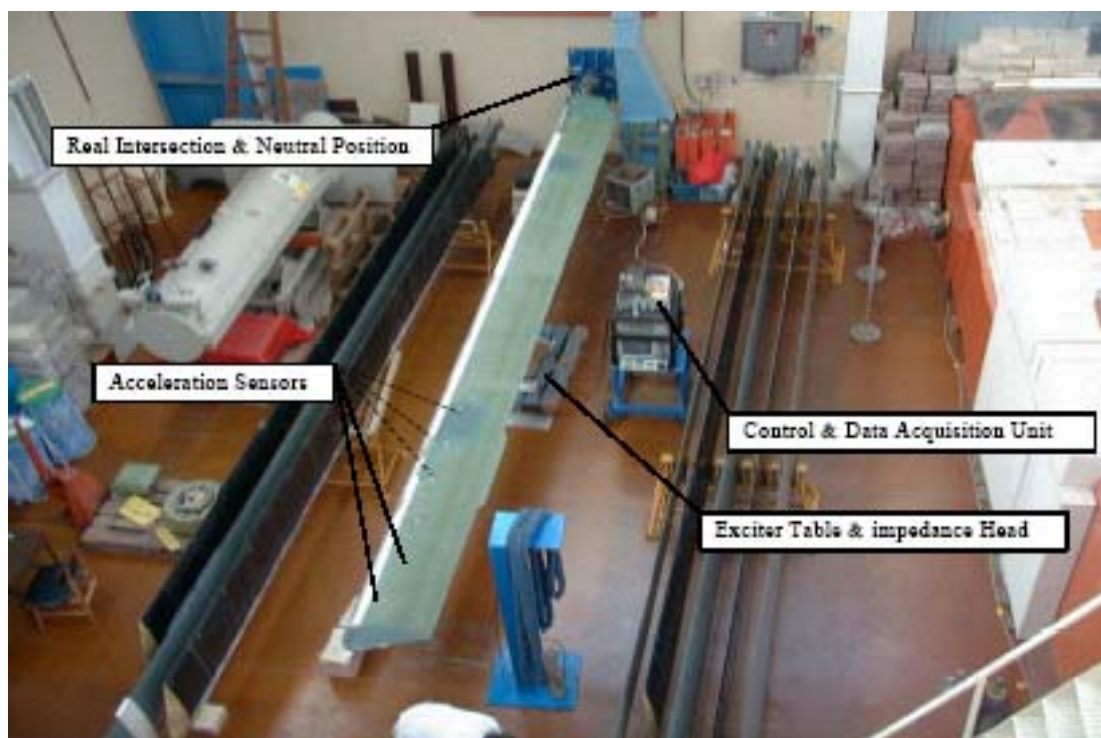
The VD measurements were performed before and after the radiography tests. The arrangement of the VD measurement is shown in Fig. 2. The vibration sensors were placed at given points of the same sectors of blades, where NR and XR were accomplished, and the damping characteristics were collaterally studied with the radiography gauging. In addition to the Statistical Energy Analysis (SEA) measurement a small exciter table (BK4810) and impedance head (BK 8000) were used. The registered vibration noises were analyzed with a dual-channel real time frequency analyzer (BK2035).

Figure 2: Arrangement of VD measurement in the Reactor Hall.

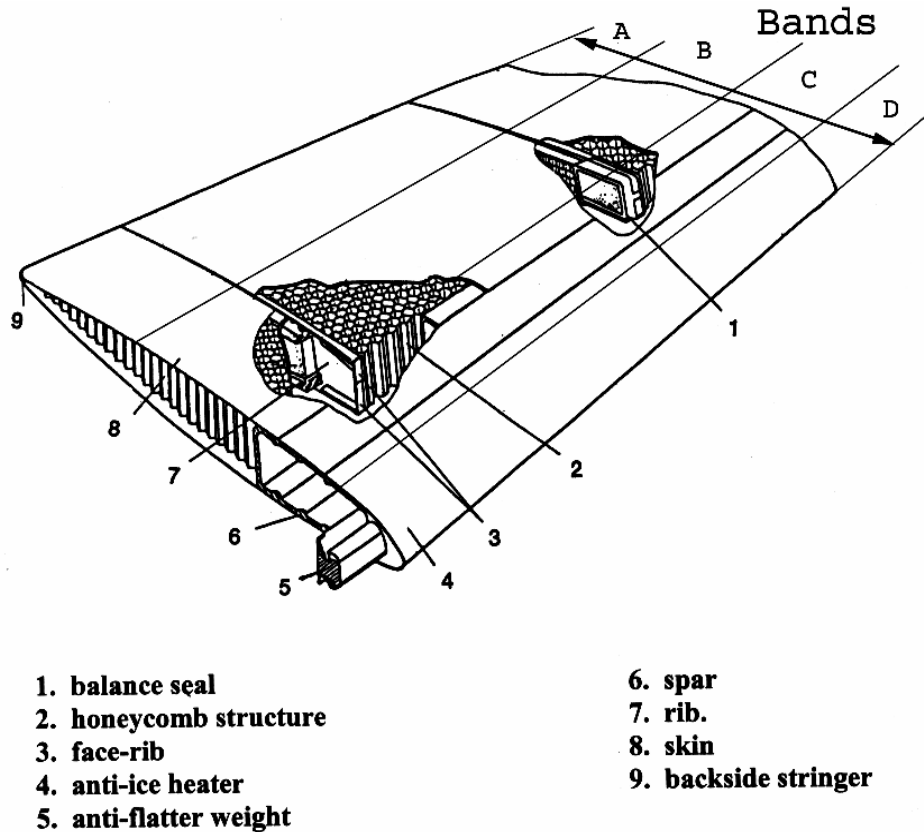
Majority of the helicopters, Mi-8, Mi-17 and Mi-24 types in the Hungarian Army's inventory are several decades old and required to continue their service even longer. One of the most important parts of them is the rotor blade. They are made of composite structures and contain 21 pieces of honeycomb construction (sector) with many bonded surfaces. The 21 sectors of the rotor blades were divided into 4 bands horizontally and 53 columns in vertically [3], as it is shown in Fig.3. The key part of the rotor blade comprises the aluminum alloy metal main holder (spar) bonded to the honeycomb structure. „A” band gives information mainly about the state of trailing edge and the backside stringer. „B” band shows the state of the honeycomb structure.

State of the bonded area on the aluminum-alloy spar is represented by „C” band. The „D” band shows the state of the anti-ice heater and front edge of the rotor blade. Every exposed picture is characterized by a capital letter for the signal of the band and two numbers for selection of the field columns to identify its position on the rotor blades.

Figure 3: The inner structure of the rotor blade.

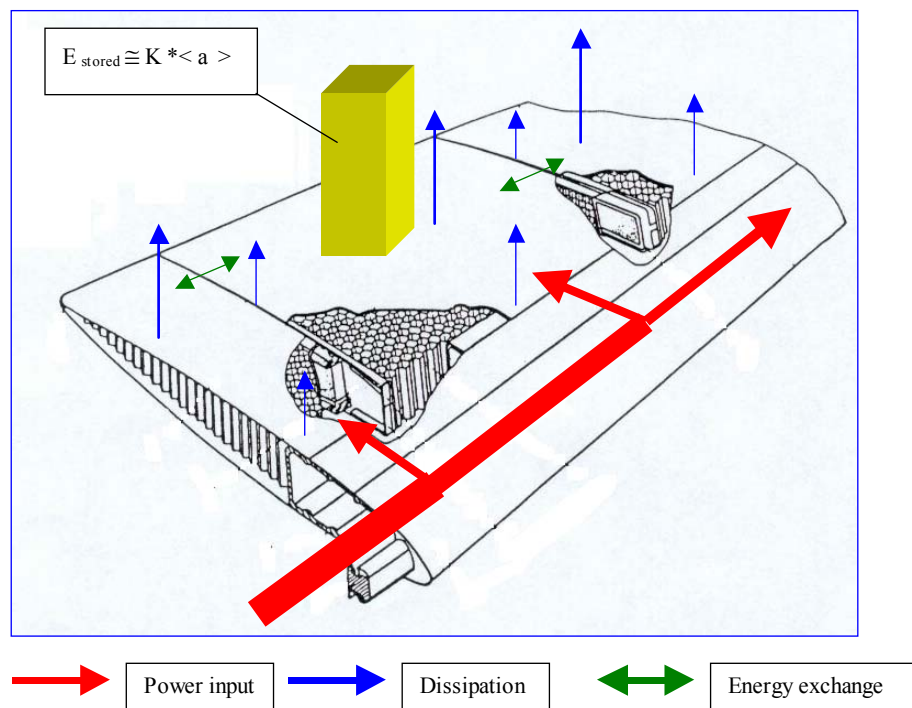
The phenomena of the energy exchange are shown in the Fig.4. Where K is a constant and (a) is the spatial average of acceleration. For SEA measurements a small exciter table (BK4810) via an impedance head (BK800) served for the energy input. The registered vibration responses were analyzed with a multi-channel real-time frequency analyzer (BK2035).

Figure 4: Energy exchange in the rotor blade.

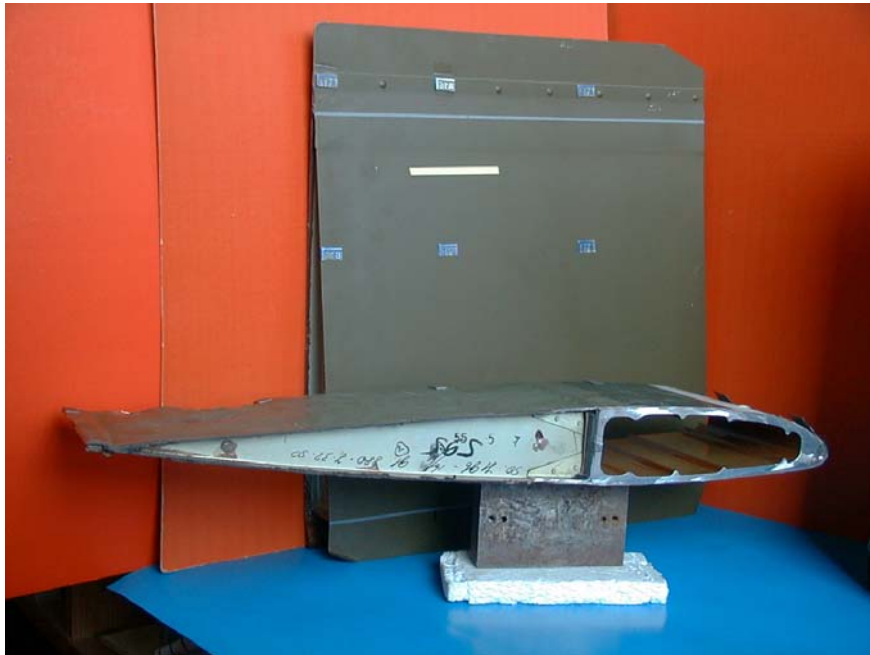
Figure 6: A lying special sample for ultrasonic test.

For the UT measurements a special object was produced (see Fig. 6.). Its XR picture (40 kV;2,5 mA) is shown in the Fig.14. It contains of some holes (diameter is 0,4mm) and some crack imitation (0,4 X 10 mm²) in the material of aluminum alloy spa with the 6FE type wire picture quality indicator on the D44 exposed picture field. In the tests to detect the cracks of main spar's section we used the principle of ultrasonic physics that the significant part of energy, using the appropriate inspection technology, rebounds in echo form from the cracks. The test would be successful when the echoes descending from the cracks simulation in sections, clearly, are detected and can be located.

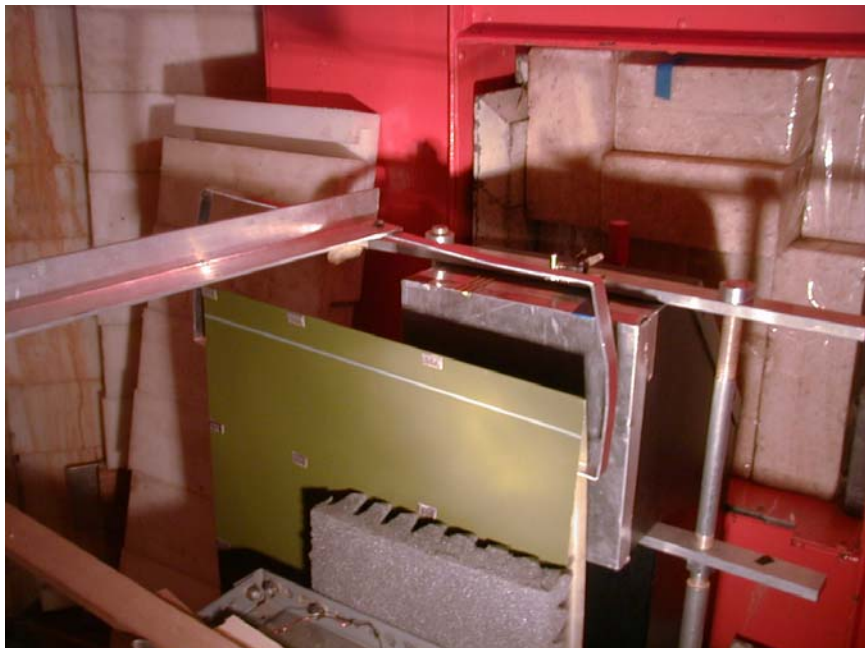
Figure 7: Reference object (original sector) in the exposure position.

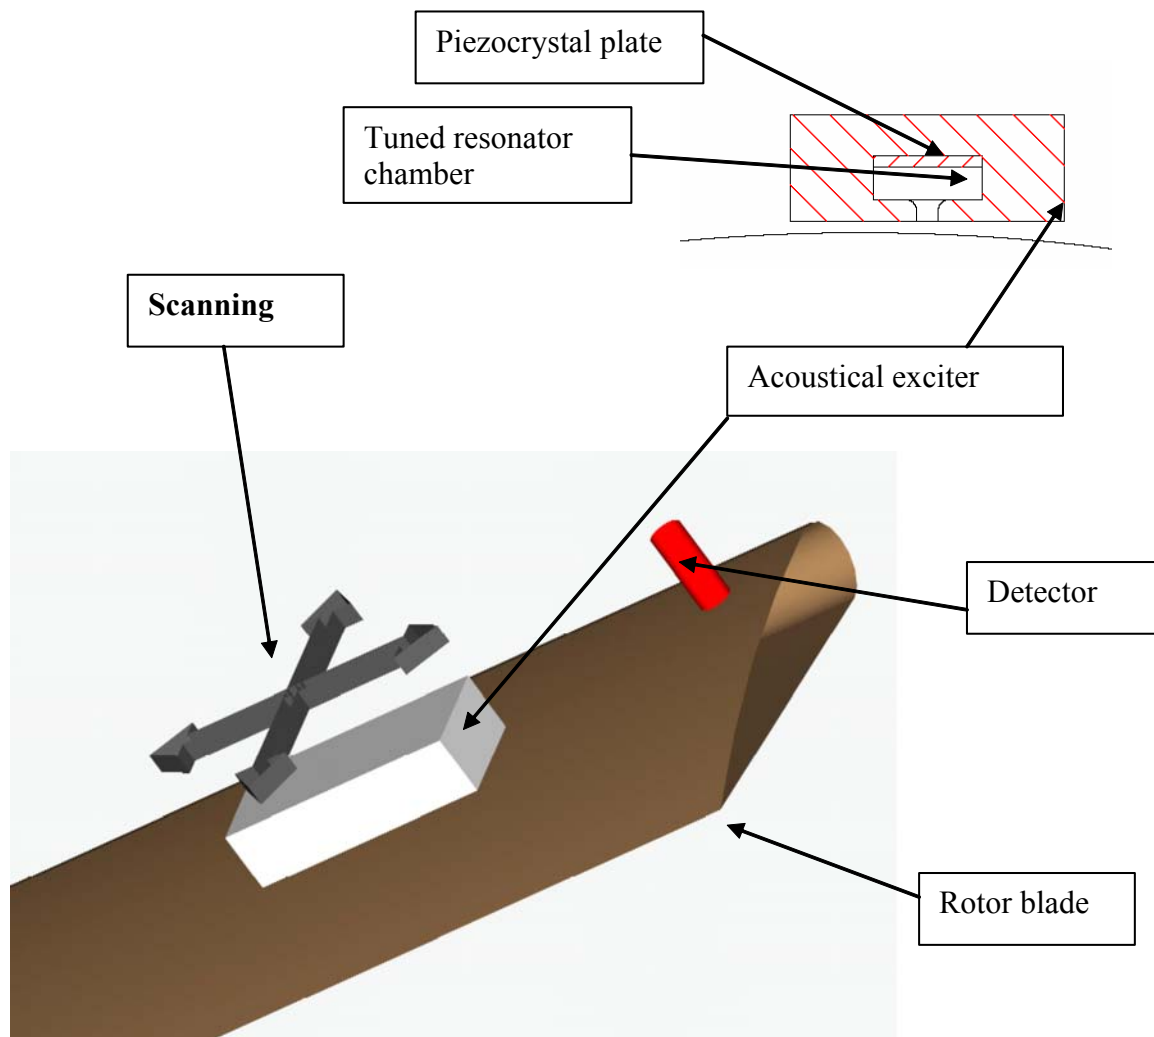
After due consideration a combination of contactless acoustical excitation and single detector has been tested last year. The main elements of the setup are shown on Fig. 8.

Figure 8: Experimental setup with contact less excitation.

The simple acoustical exciter based on “Helmholz resonator theory” gives a repeated impulse type mechanical excitation on the surface of blades. In our experiments the exciter was tuned so that the maximum power rose at 850Hz. The size of acoustical chamber and neck at this frequency produced enough power of “jets” to excite the blade within 2-3mm.
